WEEKLY REPORT

FEBRUARY 21, 2020

Memorandum

Re: Signal Warrant Analysis for FM 1902 & CR 910
Burleson, Texas

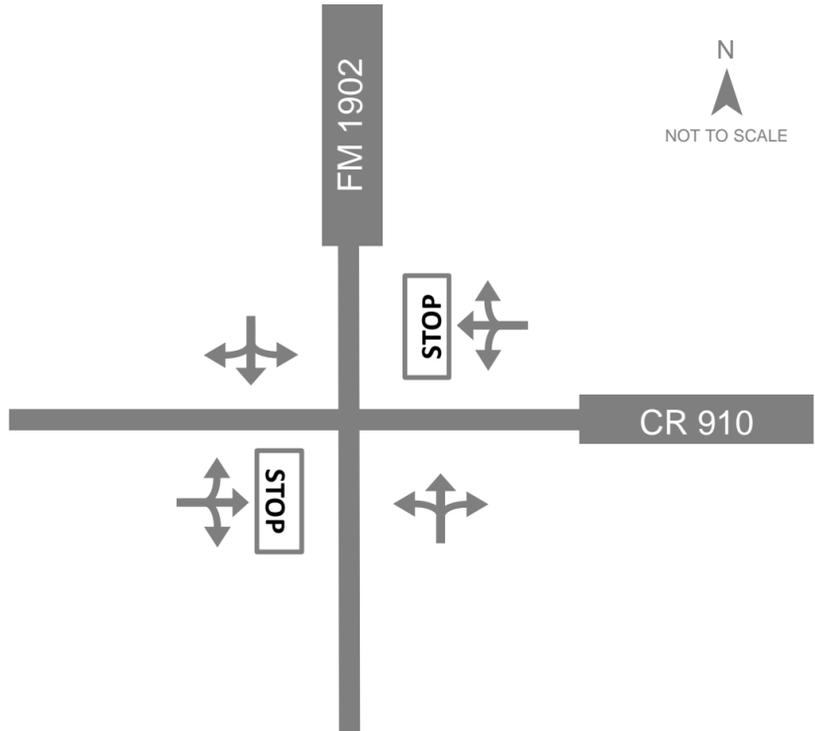
A. Existing Lane Configurations and Traffic Control

Exhibit 1.A presents the existing lane use configurations and traffic control devices at the intersection.

FM 1902 is currently a two-lane undivided facility at the CR 910 intersection with a posted speed of 50 mph. According to the Burleson Master Thoroughfare Plan, FM 1902 is a Commercial Minor Arterial (MiA-90).

CR 910 is a two-lane undivided facility on both sides of FM 1902. The eastbound and westbound approaches of CR 910 are stop-controlled at FM 1902. According to the Burleson Master Thoroughfare Plan, CR 910 is a Commercial Major Collector (MaC-70).

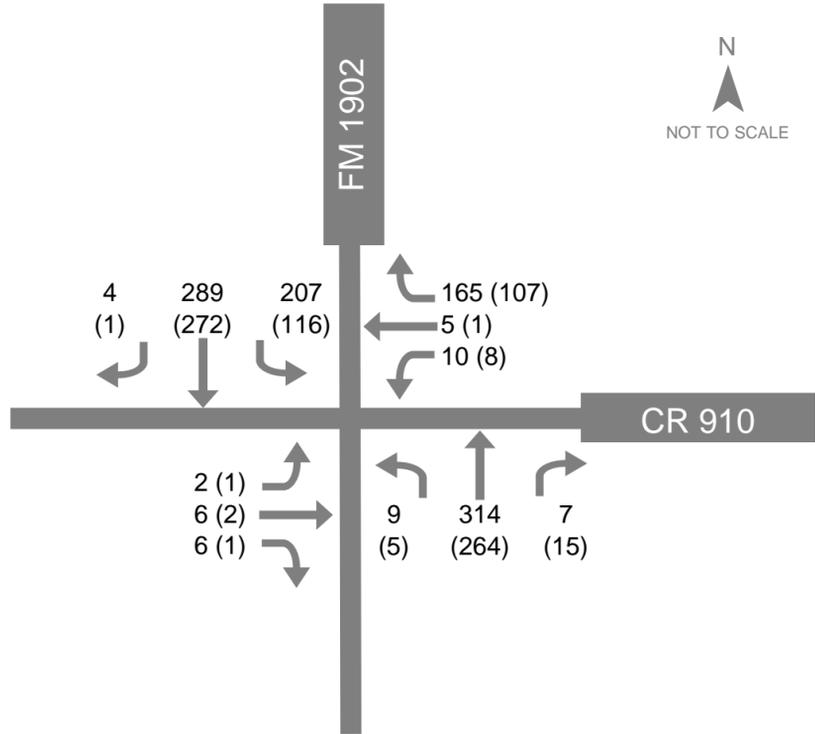
B. Existing Traffic Volumes

Exhibit 1.B presents AM and PM peak hour turning movement counts at the intersection. Copies of the raw count sheets have been provided in the **Appendix**.

LEGEND	
XX	AM Peak Hour
(XX)	PM Peak Hour

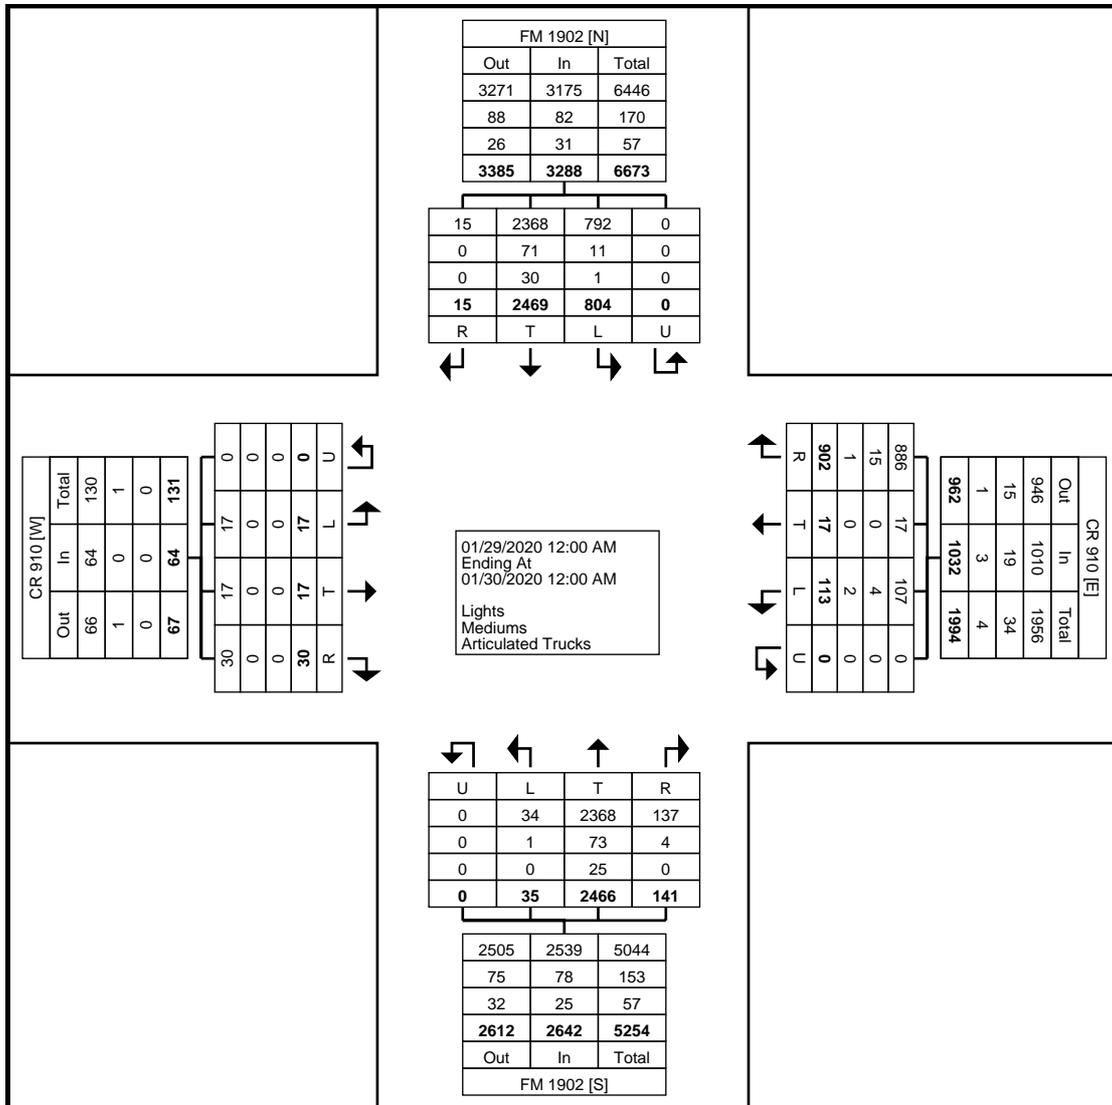
Turning Movement Data Plot

Count Name: CR 910 @ FM
1902
Site Code:
Start Date: 01/29/2020
Page No: 3

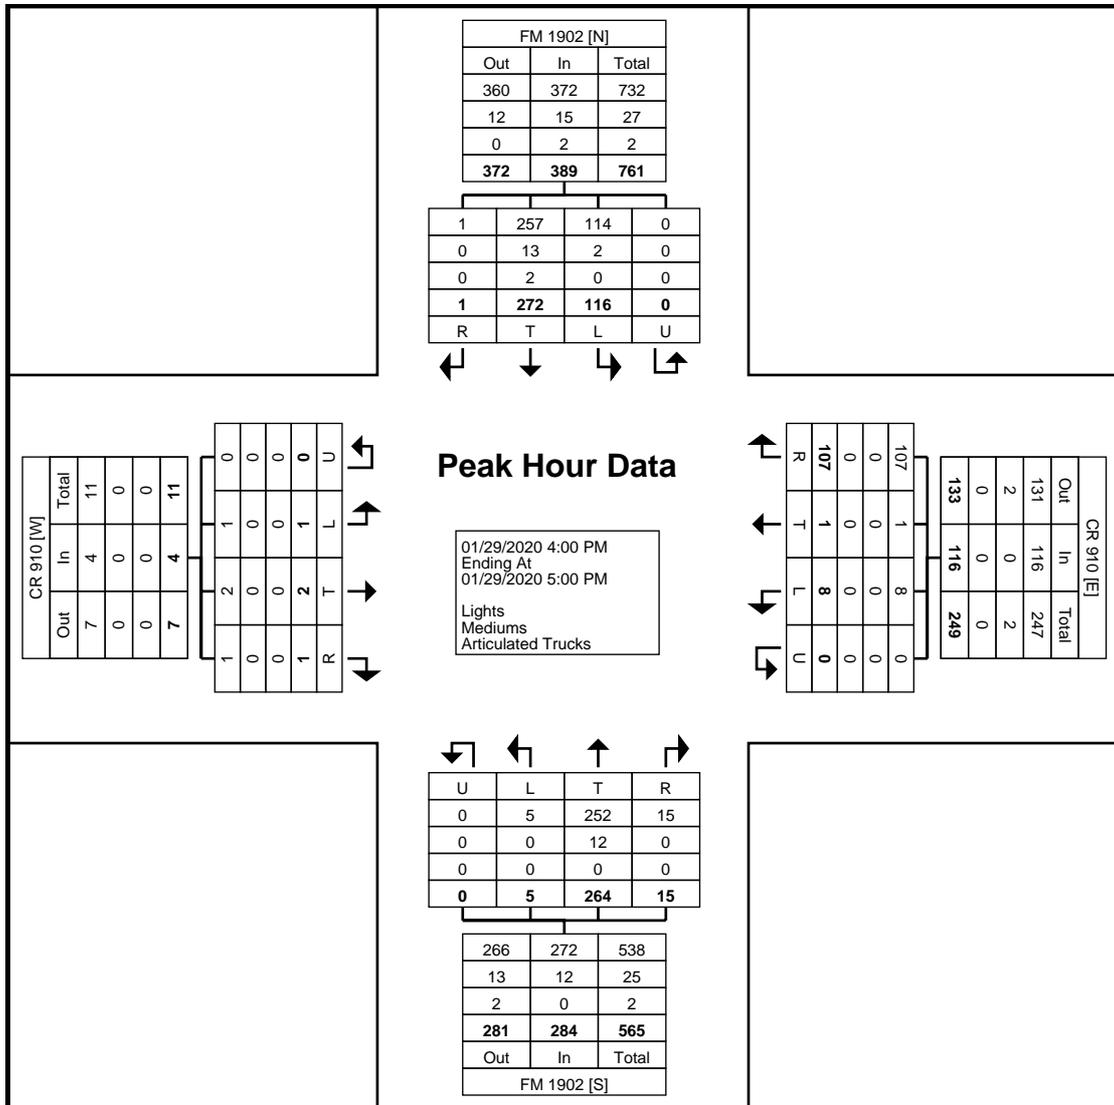
Turning Movement Peak Hour Data Plot (4:00 PM)

Count Name: CR 910 @ FM
1902
Site Code:
Start Date: 01/29/2020
Page No: 7

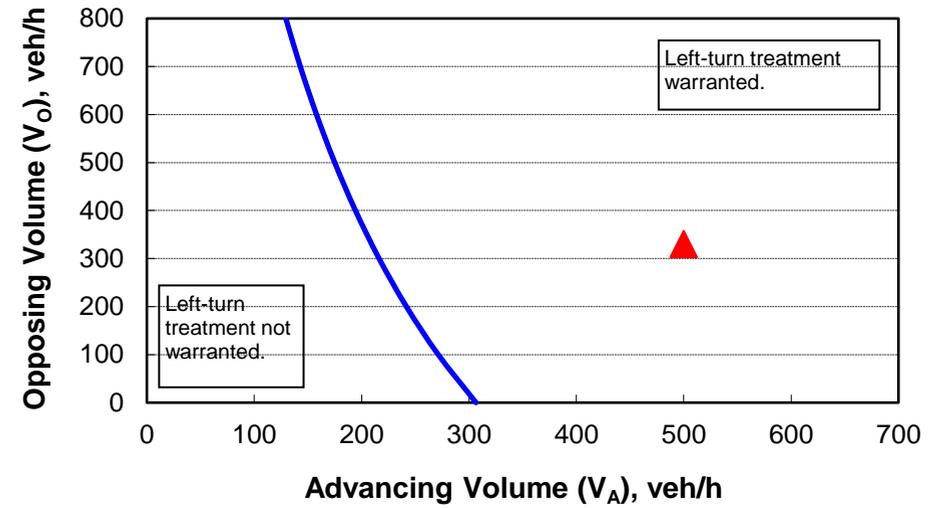
Variable	Value
Limiting advancing volume (V_A), veh/h:	209
Guidance for determining the need for a major-road left-turn bay:	
Left-turn treatment warranted.

Variable	Value
Average time for making left-turn, s:	3.0
Critical headway, s:	5.0
Average time for left-turn vehicle to clear the advancing lane, s:	1.9

Left-turn deceleration lane criteria were obtained from guidelines established by the American Association of State Highway Officials (AASHTO), which utilizes the advancing and opposing volume, as well as the left turn percentage. Based on the anticipated values, a southbound left-turn lane is warranted at the intersection.
